STUDIES OF
EXTRATERRESTRIAL DUST
AT 40 KILOMETERS

FINAL REPORT

Contract NASw-1623

Report No. 3248

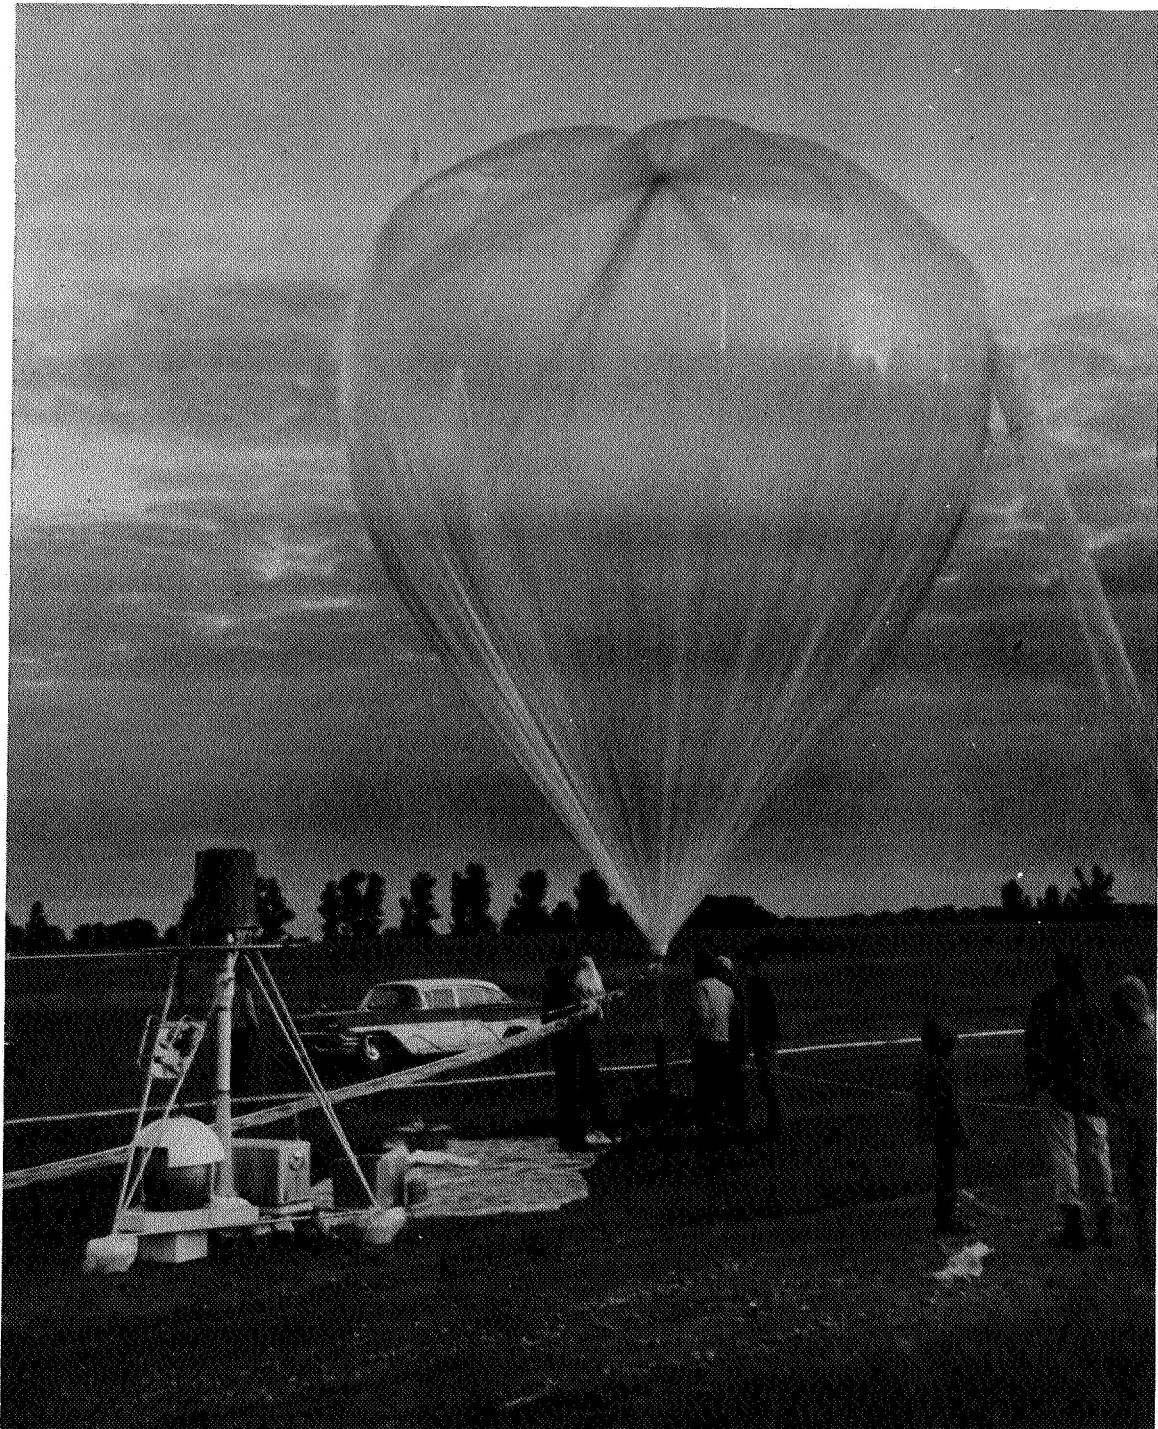
Fig. 4. Auxiliary Lift Balloon and Sampler

The second NASA balloon flight to sample extraterrestrial debris was launched Wednesday, 19 July 1967. Payload configuration is shown in Fig. 4.

After an extensive search the following day, the payload gondola and instrumentation were located in a field of a few miles north of Buffalo, Wyoming. Examination of the payload revealed that the collection head had broken off and was missing. The collection head was subsequently located near the remnants of the balloon vehicle, about 10 miles west of the gondola impact position.

- 2) At release, the payload was detached and a static line attached to the load line pulled the parachute free of its plastic container.
- 3) For an undetermined reason, the parachute did not open immediately. We know from the data recorded on-board that less than 8 seconds elapsed from cut-down to parachute opening, but this was evidently sufficient to allow the payload to reach an excessive fall velocity.

- 4) Inspection of the gondola indicated that it was subjected to a rather violent shock at the instant of parachute opening. In addition, there were indications that the gondola had rotated so that the initial opening shock was not along the vertical payload axis, but was to one side, resulting in a crack-the-whip effect which caused the bolts holding the sampler to shear. When found, the sampling head was jammed open in the fully extended position. This indicates to us that the gondola had probably rotated past 90° at the time the parachute opened, and that inertial forces were sufficient to jerk the sampler head outside of the protective cannister where it jammed. In the absence of such forces, retaining springs within the sampler would have kept the unit closed during free-fall. The fact that the rest of the gondola remained substantially intact is probably due to the steel aircraft cables anchored to the gondola base.

- 5) Detachment of the sampler head from the payload during the parachute opening shock was also confirmed by the on-board flow sensor recordings which indicated a high reverse flow through the ejector pump during descent. Normally, there would be no flow passage through the system with the closed sampling head attached.

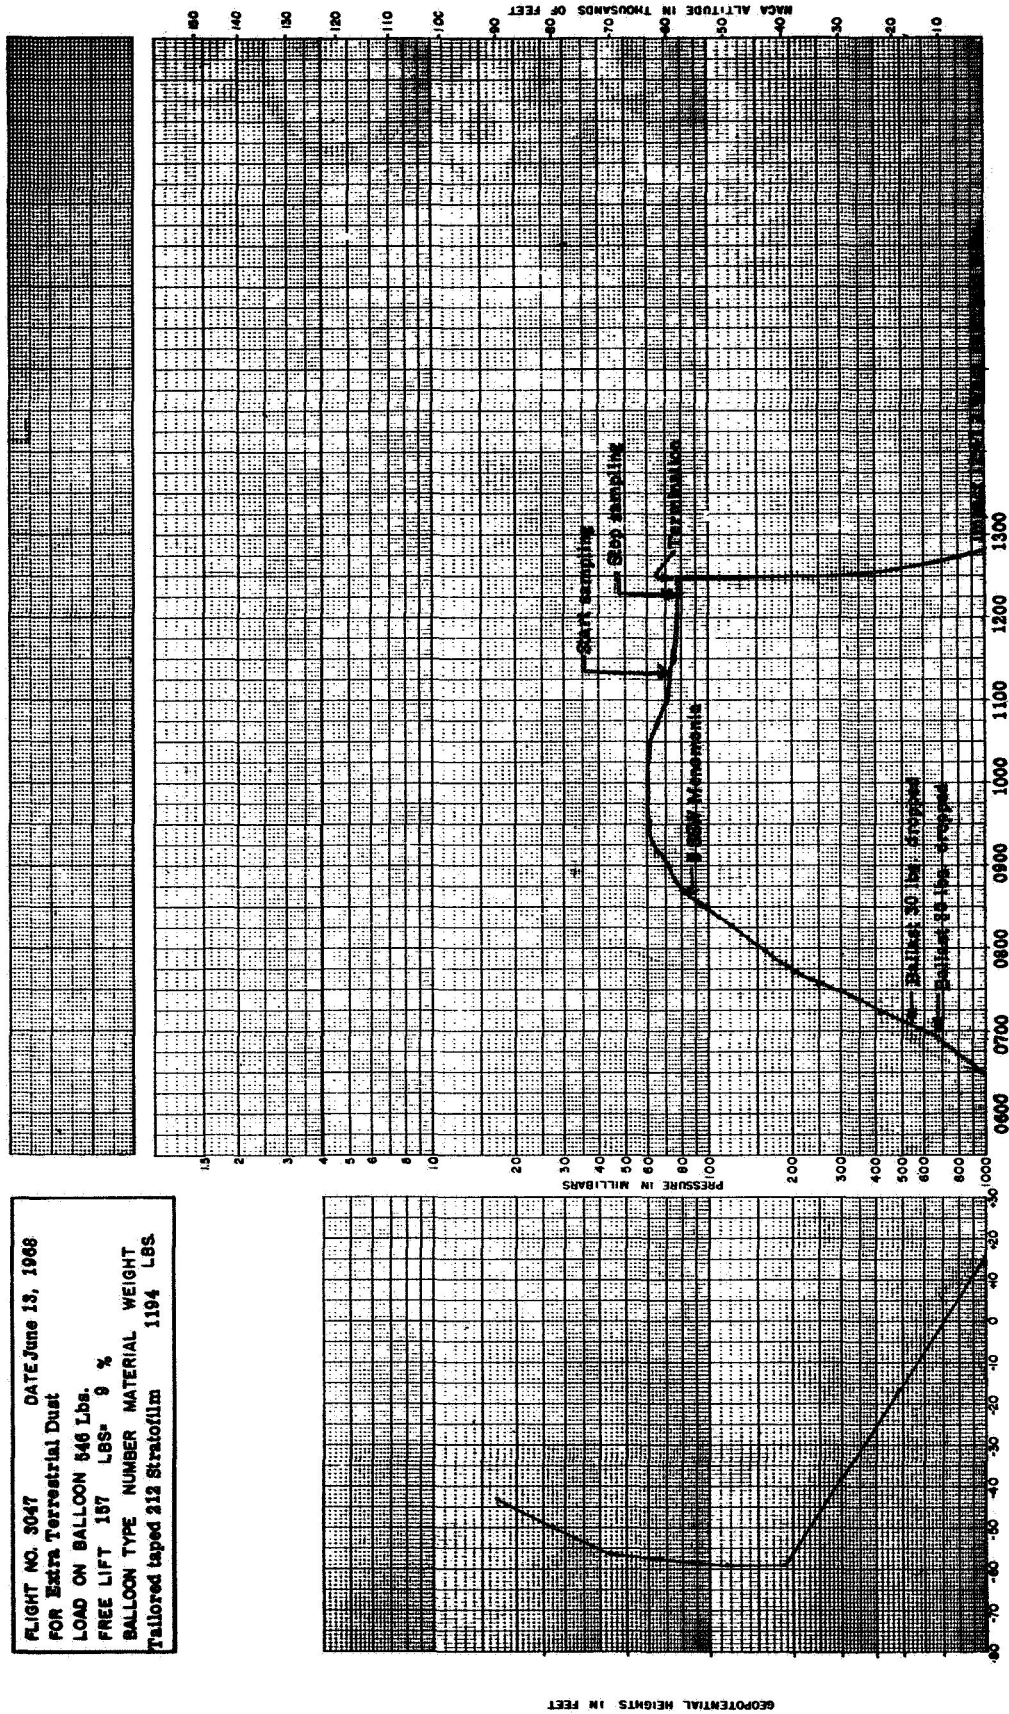
Fig. 5. Time Altitude for Flight 3047

Unfortunately, the balloon never reached the 70,000-ft level. After passing 30,000 ft, the rate of ascent grew progressively slower and the leveled off at 63,500 ft. At 9:30 CDT, the balloon began a slow descent.

The time-altitude for Flight 3047 is shown in Fig. 5.

In view of evidence presented by the time-altitude flight profile, it is our opinion that failure to reach sampling altitude was caused by a leak in the balloon. Such a leak might stem from any of several causes including 1) faulty balloon materials, 2) faults in construction, 3) damage incurred during inflation and launch, and 4) stresses produced by wind shears during ascent.

No direct evidence pointing to one or a combination of these possibilities as a probable cause of failure has been found.
